# MICROSCOPIC EXAMINATION OF STEEL

HENRY FAY, Ph. D., D. Sc.

*Professor of Analytical Chemistry, Massachusetts Institute of Technology  
Consulting Metallurgist, Watertown Arsenal*

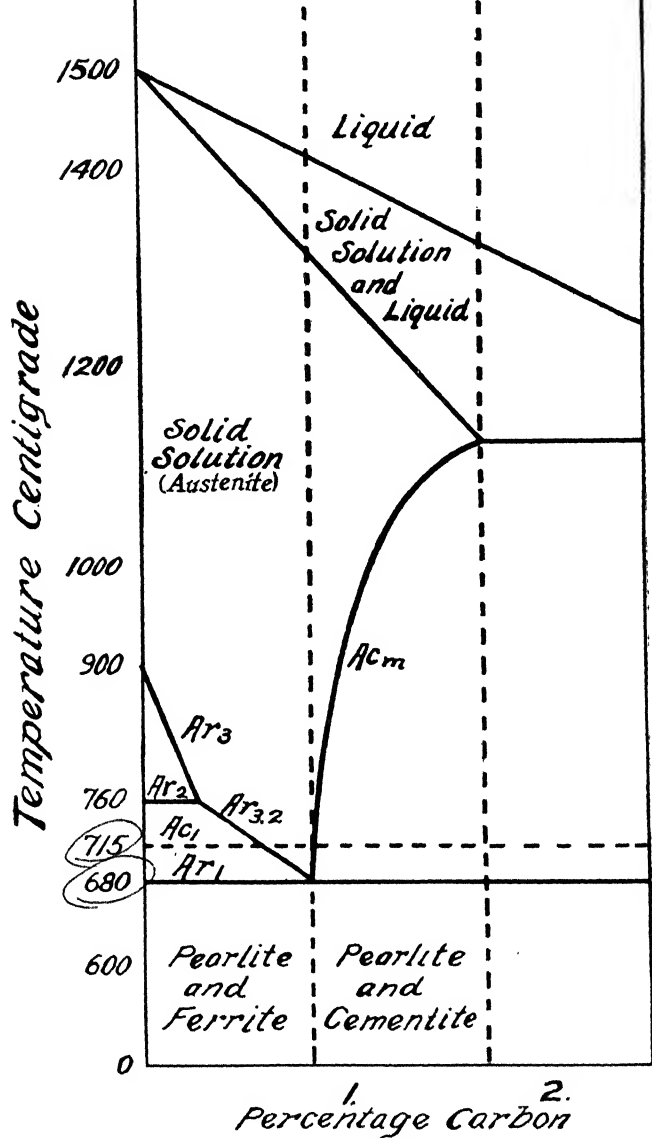
Fig. 1

Portion of iron-carbon diagram

constituents, iron and iron carbide. The  $Ac_1$  point is approximately  $30^\circ$  higher than the  $Ar_1$  point, and represents the beginning of the formation of solid solution. In steels containing 0.85 per cent carbon there is but one critical temperature at which the solid solution decomposes into its constituents, iron and iron carbide. This is known as an eutectoid steel, and its microscopic constituent is pearlite. Pearlite always etches dark, and under high magnifications is shown to consist of alternate laminations of iron and iron carbide. Steels containing less than 0.85 per cent carbon are hypoeutectoid, and contain the microscopic constituents ferrite and pearlite, the amount of the latter increasing with the per cent of carbon. Steels containing more than 0.85 per cent carbon are hypereutectoid, and contain the microscopic constituents cementite (iron carbide,  $Fe_3C$ ) and pearlite. These facts are illustrated in the diagram. (Fig. 1.)

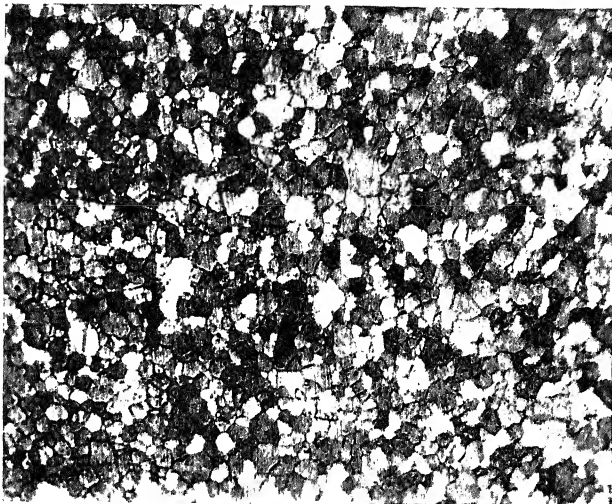
PHOTOGRAPH NO. 1. X75.

0.06% carbon. Approximately pure ferrite.

Photograph No. 1 shows the characteristics of a carbonless iron in which the whole field is made up of granules of ferrite. With the introduction of carbon there is a decrease in the amount of ferrite and the constituent pearlite begins to appear. This is shown in photograph No. 2 for a steel containing 0.18 per cent carbon. Inasmuch as steels containing 0.85 per cent carbon contain 100 per cent pearlite, and as pearlite is composed of ferrite and cementite, in this steel containing 0.18 per cent carbon there ought to be approximately 20 per cent of the field made up of pearlite. In a steel containing 0.5 per cent carbon there should be 58.8 per cent pearlite. Such a steel is shown in photograph No. 4. A eutectoid steel containing 0.83 per cent carbon and practically 100 per cent pearlite is shown in photograph No. 7. Under higher magnifications pearlite shows the laminated structure shown in photograph No. 8. In hypereutectoid steels the excess carbon beyond that necessary to form pearlite, separates as free cementite and the amount of free cementite can be calculated. Inasmuch as the whole field is made up of pearlite

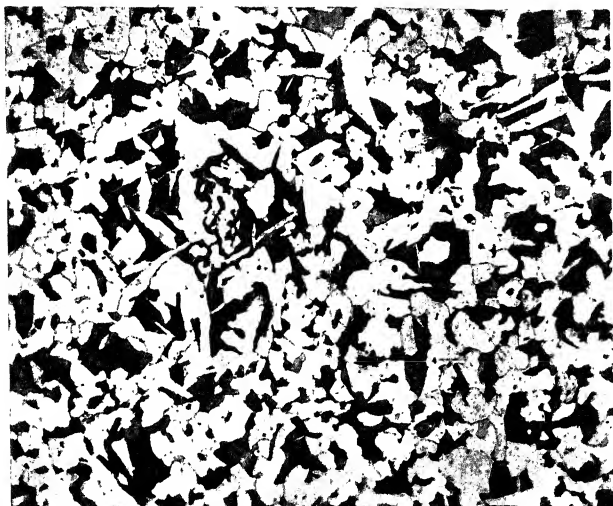
PHOTOGRAPH NO. 3. X75.

0.32% carbon. Ferrite (white) and pearlite (dark).

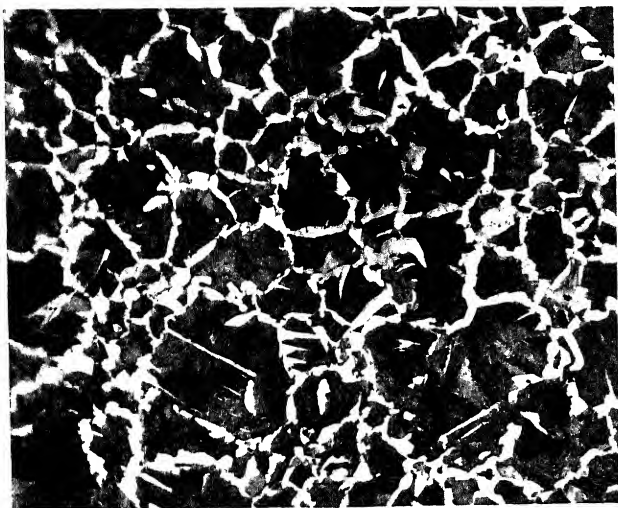
PHOTOGRAPH NO. 4. X75.

0.49% carbon. Ferrite (white) and pearlite (dark).

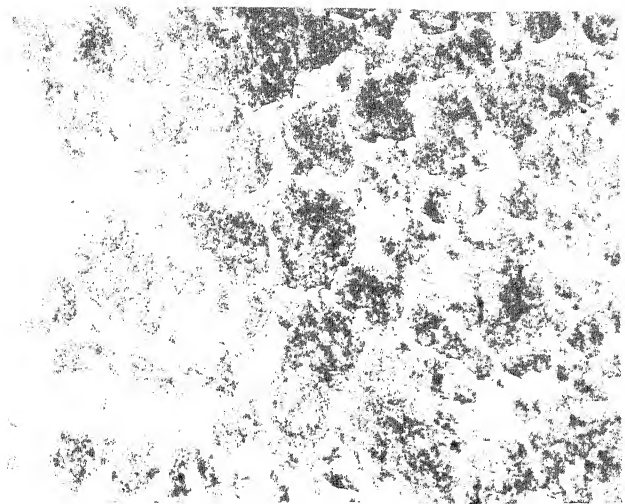
PHOTOGRAPH NO. 5. X75.  
0.57% carbon. Ferrite and pearlite.

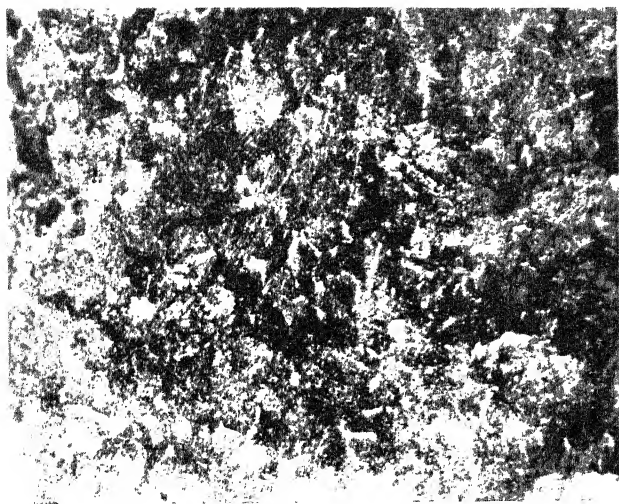
PHOTOGRAPH NO. 6. X75.  
0.71% carbon. Ferrite and pearlite.

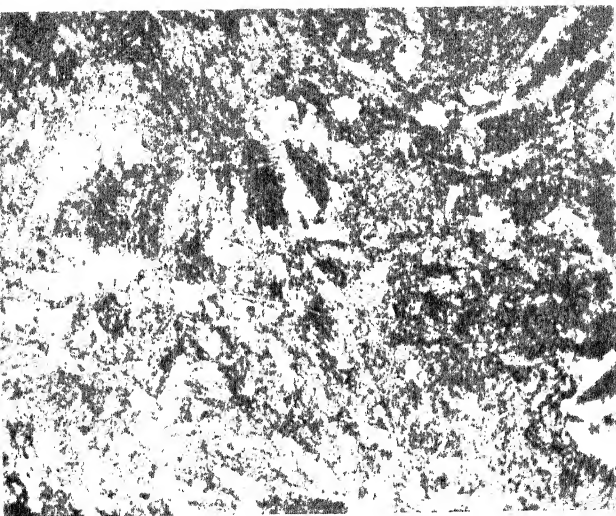
PHOTOGRAPH NO. 1. X75.

0.83% carbon - Pearlite

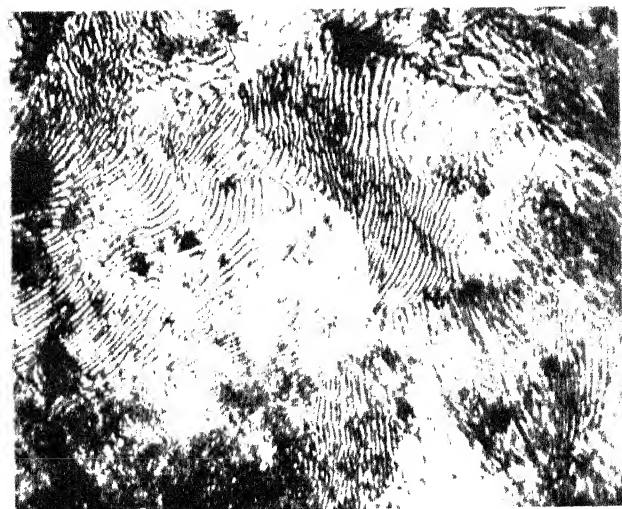
PHOTOGRAPH NO. 2. X485

0.83% carbon - Pearlite

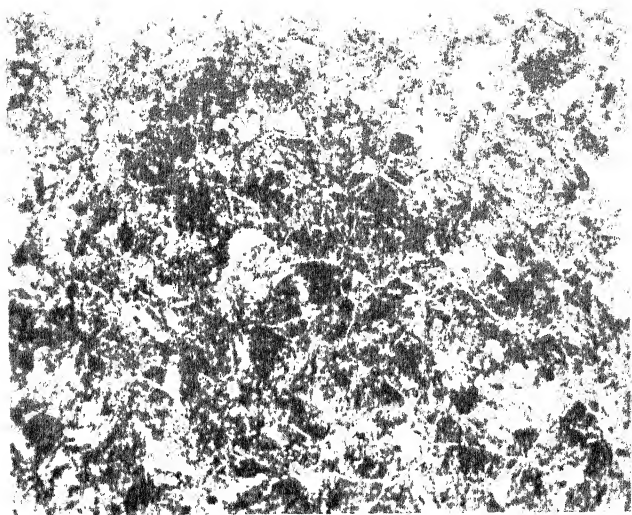
PHOTOGRAPH NO. 9 X75

1.23 carbon. (Pearlite and cementite white).

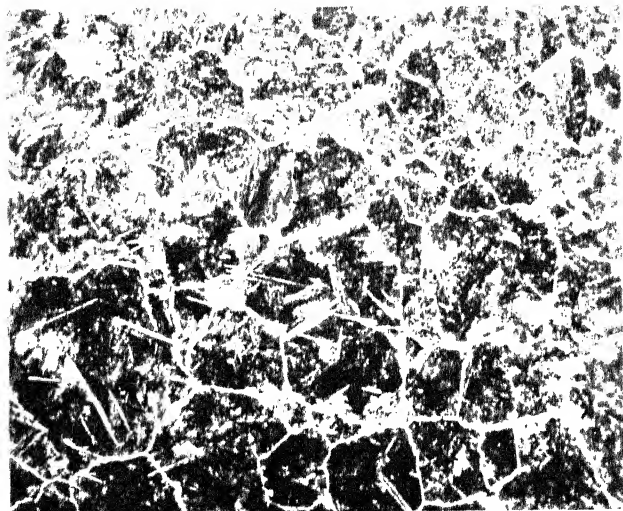
PHOTOGRAPH NO. 10 X75

1.46 carbon. (Pearlite and cementite white).

and cementite and it requires 0.85 per cent of the carbon to form the pearlite, the difference between the total carbon and 0.85 per cent carbon gives the amount of carbon available to form cementite. Thus in a steel containing 1.25 per cent carbon there is available for cementite formation 0.4 per cent carbon and as cementite,  $\text{Fe}_3\text{C}$ , contains 6.67 per cent carbon the 0.4 per cent carbon would furnish approximately 6 per cent cementite which would occur in the free state, and the steel would contain 94 per cent of pearlite and 6 per cent cementite. See photograph No. 9. It is thus evident that by microscopic examination a rough determination of carbon may be made on *slowly* cooled steels. Photograph No. 10 shows a steel containing 1.46 per cent carbon — approximately 9 per cent cementite — in which the white constituent is cementite.

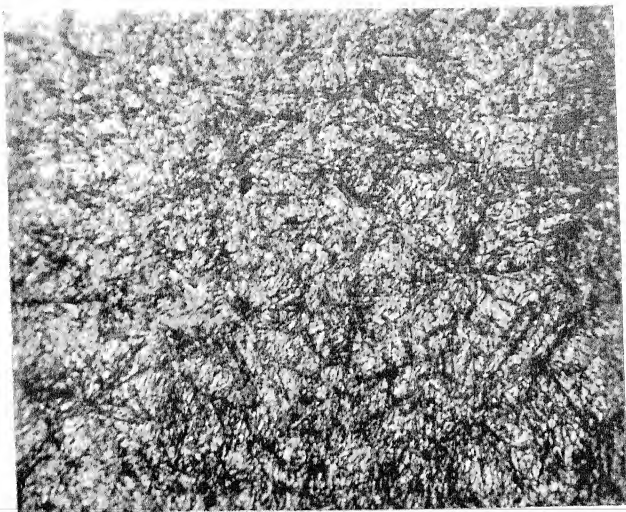
PHOTOGRAPH NO. II. X75.

Martensite.

Photograph No. 11 shows the characteristic appearance. Commercially martensitic steels are unimportant on account of their extreme brittleness and they are found only rarely.

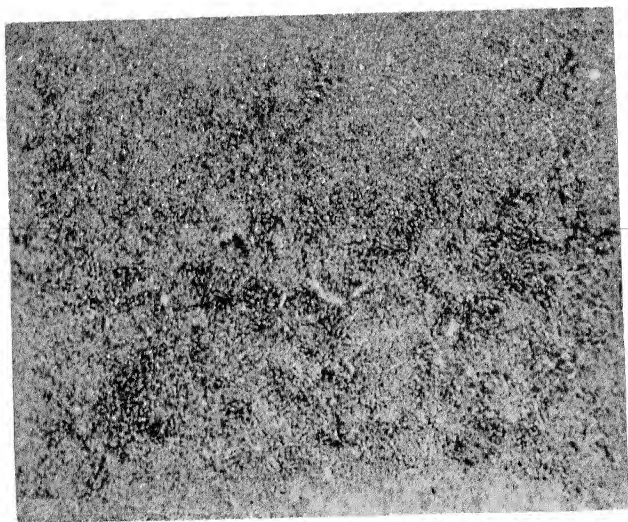
PHOTOGRAPH NO. 12. X75.

Troostite.

If heated to temperatures below  $A_{c1}$ , the effect produced will vary with the temperature. The lower the temperature of re-heating the smaller is the tendency toward stable equilibrium; the higher the temperature the more stable is the product produced. Practically any degree of hardness may be produced, varying from glass-hard to extreme softness, by properly regulating the temperature of the heating. There are then two extremes, the martensitic steels formed by quenching from above  $A_{c1}$  and the pearlitic steels formed by cooling slowly from  $A_{r1}$  or above. Intermediate between these extremes are steels in which more or less of the unstable solid solution has been partly converted to more stable forms. Such forms are represented microscopically by troostite and sorbite. Troostite, formed by tempering at relatively low temperatures, represents the first stage in the breaking down of the unstable equilibrium and is characterized by the amorphous or slightly granular structure. Etching with alcoholic nitric acid the surface usually blackens immediately from separated carbon. Photograph No. 12 shows troostite.

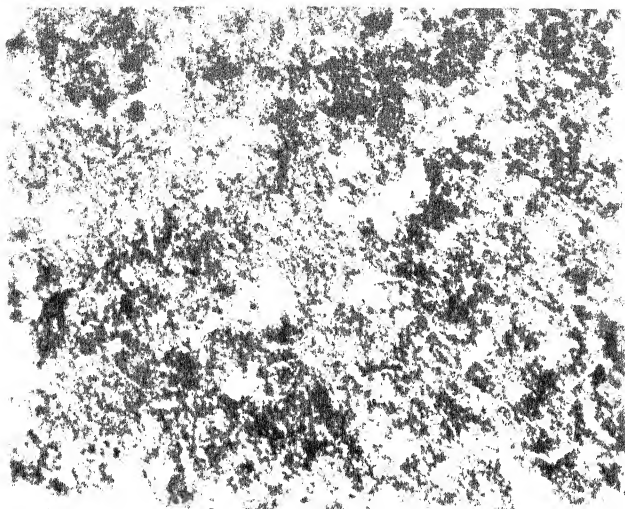
PHOTOGRAPH NO. 13 X75.

Sorbite

Sorbite steels are those which have been quenched and heated at a higher temperature and thus represent a more stable state of equilibrium. They are characterized by having a peculiar grayish color, and the structure is better defined than troostite. The particles of iron carbide have not assumed definite lamellations with ferrite as in pearlite, but are very much more distinct than in troostite. Photograph No. 13 shows sorbite.

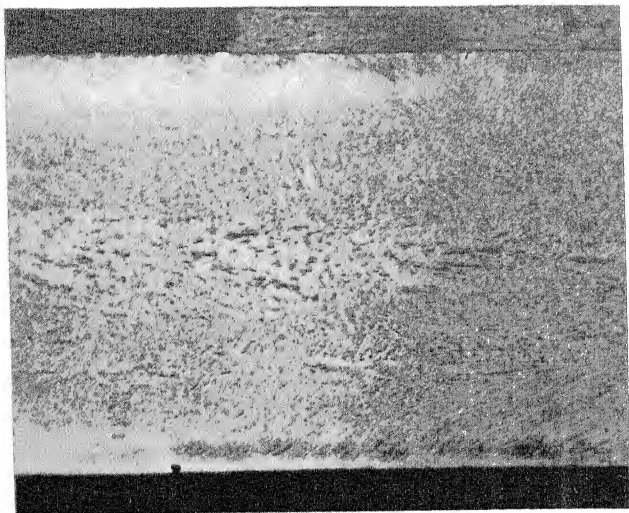
PHOTOGRAPH NO. 19. ONE-THIRD SIZE.  
Ingot structure in steel.

The presence of ingot structure such as shown in photograph No. 19 indicates that the heat treatment and forging have not been sufficient to wipe out the crystallization which occurred on the solidification of the metal. It is not definitely known that the presence of ingot structure is harmful, and it is frequently accompanied by excellent microstructure, but it serves as an indication of the heat treatment to which the metal has been subjected after solidification. It is believed that such a structure would not be found in the best steel, and it is further believed that metal showing ingot structure would be more liable to rupture from shock than metal in which the ingot structure had been wiped out by heat treatment and forging.

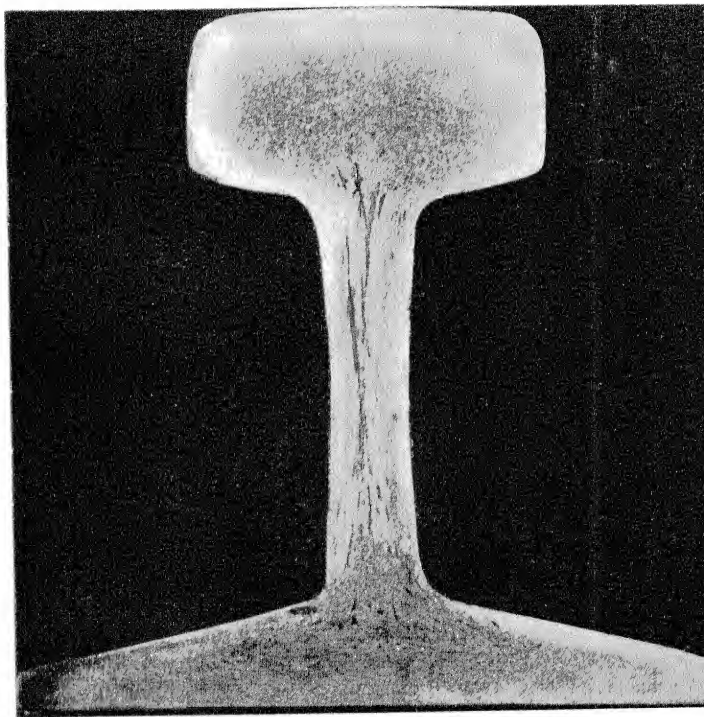
PHOTOGRAPH NO. 20.  
Cross section of steel rail showing segregation in center of head, web, and base.

Segregation of carbon or phosphorus may be brought out most successfully by etching a complete cross section of the metal under investigation, such as shown in photograph No. 20 of a rail section in which segregation of carbon is shown, or in photograph No. 21 of a cross section of a piece of cold-rolled shafting

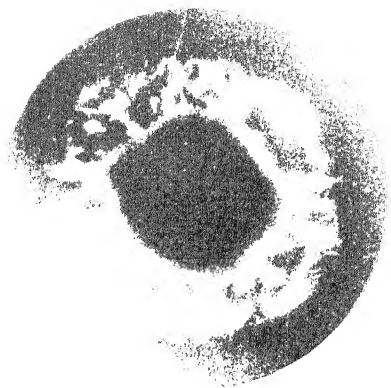
PHOTOGRAPH NO. 21.

Segregation of phosphorus in cold-rolled charting.  
Etched with iodine. White areas

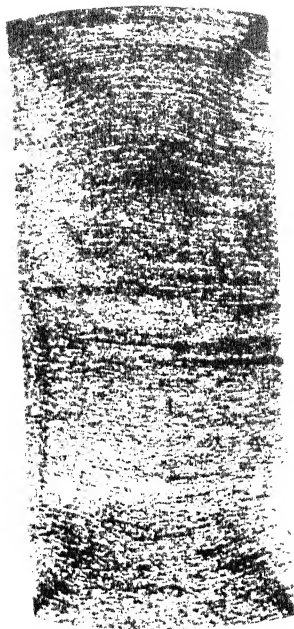
PHOTOGRAPH NO. 23.

Area of strained metal brought out by etching with copper ammonium chloride.

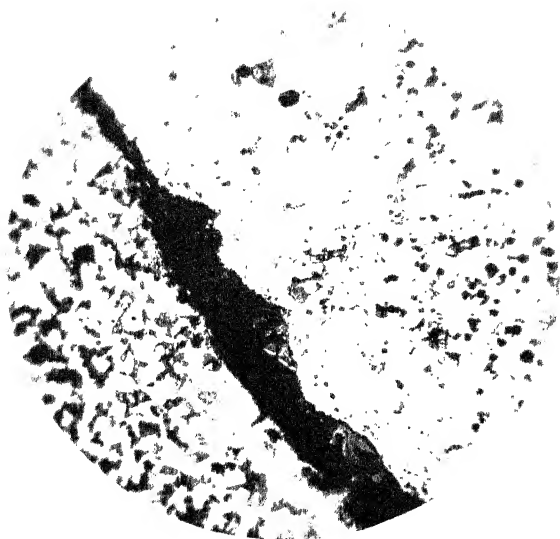
PHOTOGRAPH NO. 24. X50.

Crack, slag, and decarbonized area found on the base of a steel rail.

The inclusion of oxide is frequently accompanied by partial decarbonization, and is most frequently found on or near the surface. An example of this is shown in photograph No. 24, in which it is seen that a crack has penetrated through the slag, probably mill scale, and in the crack are the remnants of the slag. On the left of the crack is the normal structure and on the right is a decarbonized area containing slag. Such an area would probably be large enough to show to the naked eye and would be considered unsafe. Other examples of oxide inclosures are cited on pages 14 and 15, in the discussion of the failure of 10-inch gun and 14-inch gun lever.

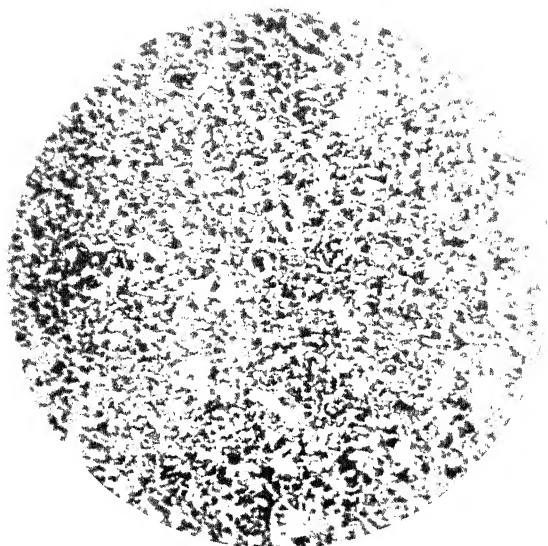
PHOTOGRAPH NO. 29. X75.

Microstructure of cast steel ingot forged to 1450 F. (788° C.)

Elastic Limit	50,500
Tensile Strength	83,600
Elongation	27.5

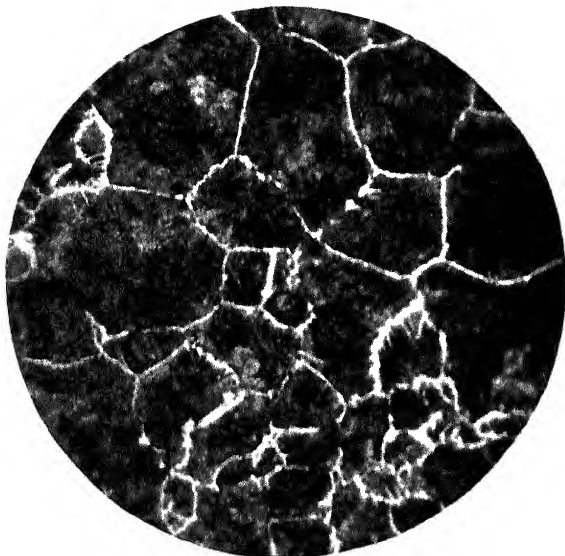
PHOTOGRAPH NO. 30. X75.  
Coarse microstructure in gun steel.

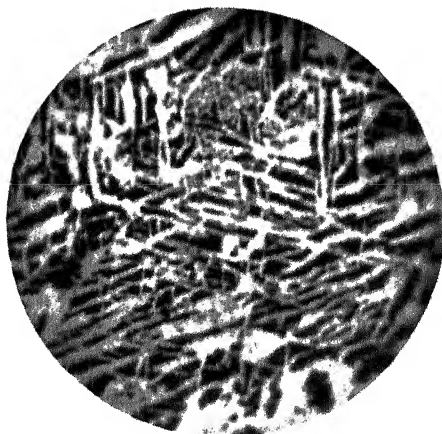
PHOTOGRAPH NO. 31. X50  
Crystalline structure in rail steel.

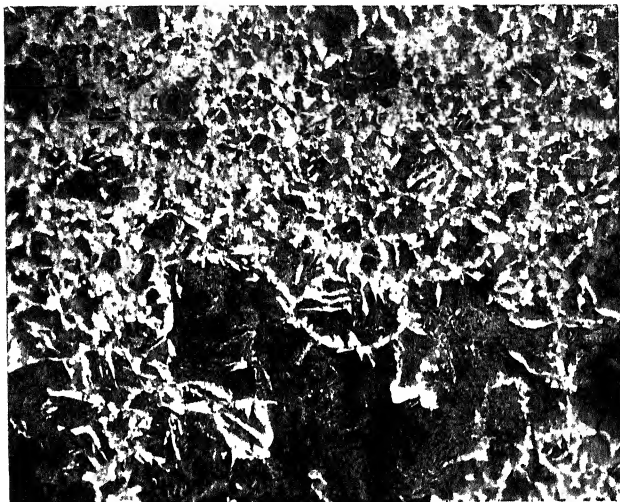
PHOTOGRAPH NO. 32. X75.

Microstructure showing incomplete heat treatment.

Failure to obtain uniformity of structure is shown in photograph No. 32. Discussion of photographs Nos. 49, 51, and 53 will be found under the discussion of some of the special cases, viz., the failure of 14-inch gun lever arm. Dangerous overheating is shown in photograph No. 33. In this case the material is burnt, as is shown by the oxide between the granules of pearlite.

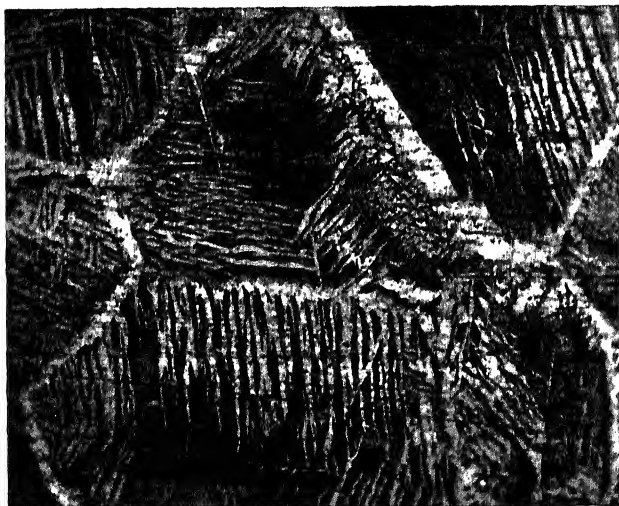
PHOTOGRAPH NO. 33. X75.

Microstructure of overheated steel.

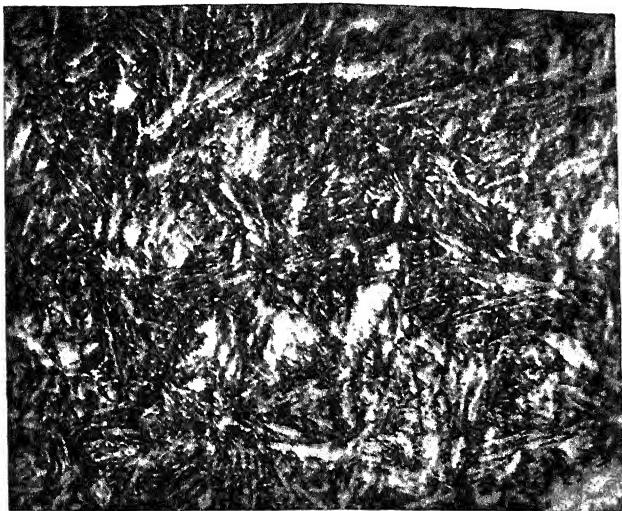
PHOTOGRAPH NO. 34. X500.

Microstructure of forging which had been originally martensitic, and in tempering this structure has not been completely eliminated.

observed that the original martensitic structure is completely removed by the tempering process. This point is illustrated by photograph No. 34 in which there are distinct remains of the original martensitic structure. Such a steel properly heat treated ought to show a structure similar to photographs Nos. 12 or 13.

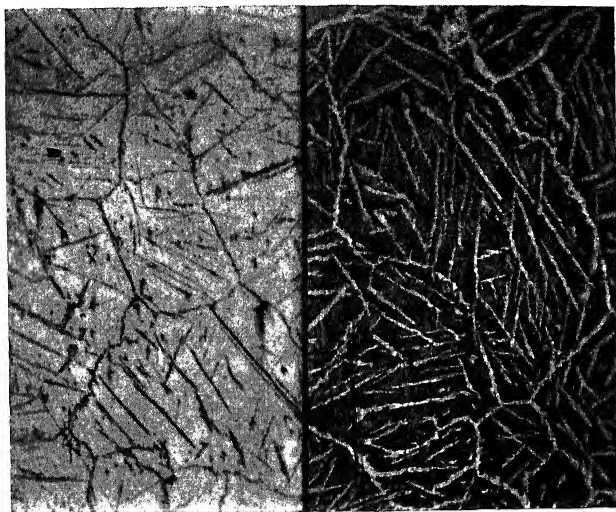
PHOTOGRAPH NO. 35. X65.

Microstructure in center of broken recoil spring showing excess cementite, indicating high carbon. Left, white lines are cementite etched with nitric acid solution; right, dark lines are cementite etched with sodium picrate solution.

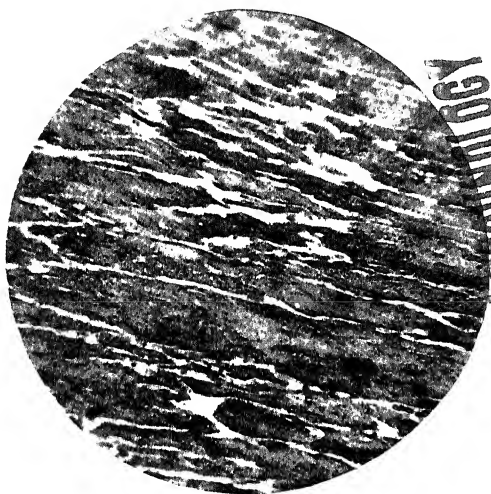
PHOTOGRAPH NO. 36. X50.

Microstructure of steel subjected to cold work, and  
showing distortion of grain.

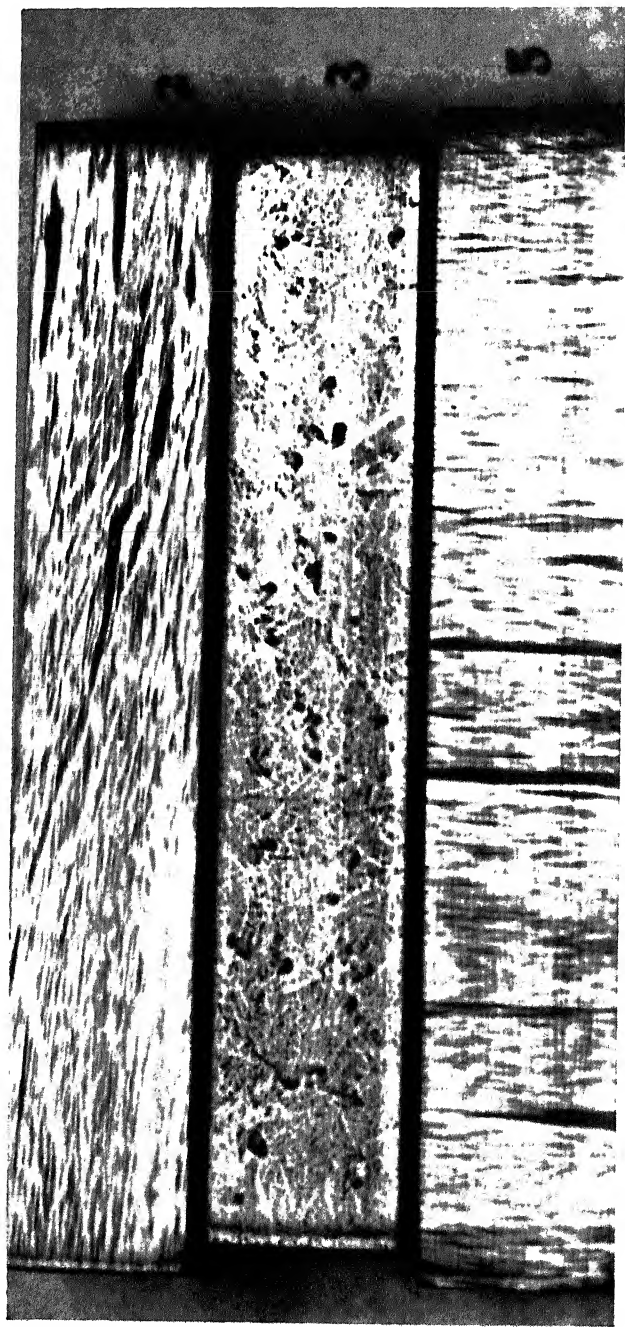
PHOTOGRAPH NO 38

Macrostructure of test bars of D-methyl stear wax surfaces cut longitudinal, radial 3 and tangential 2 to axis.

Photographs Nos. 38 and 39 show the macrostructure of the steel when etched with iodine, the specimens shown in photograph No. 38 being taken longitudinally, radially, and tangentially. The segregation of phosphorus is indicated by dark lines in pieces Nos. 2 and 5 of photograph No. 38 and in pieces 3 and 4 of photograph No. 39 and by the dark spots in piece 3. Photograph No. 39 shows the metal cut from the surface of the fracture and treated in the same manner, as shown in piece marked 5 in photograph No. 38, and in other pieces not shown. The dark streaks were found to be elongated parallel to the direction of forging, and it is reasonable to assume that the elongation will always be parallel to the surface of the metal forged. By inspection of the two larger pieces of metal from the region of the crack (photograph No. 39) it will be seen that there is considerable distortion of the phosphide area

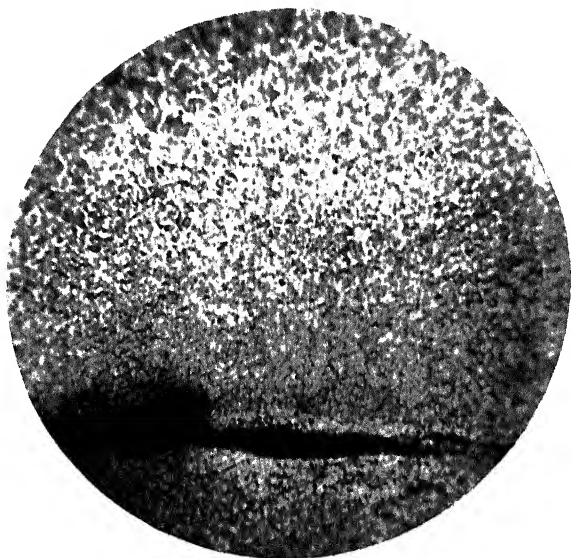
PHOTOGRAPH NO. 40. X50.

Crack and slag, with decarbonized area in 10-inch rifle.

Examination of sections in the vicinity of the crack showed many fine cracks, slag inclusions, and carbonless areas. The cracks led to slag, and where the slag was found there were also found decarbonized areas. Photograph No. 40 shows a crack ending in slag and surrounded by decarbonized iron. The course of the slag was quite irregular, as shown in photographs Nos. 41 and 42.

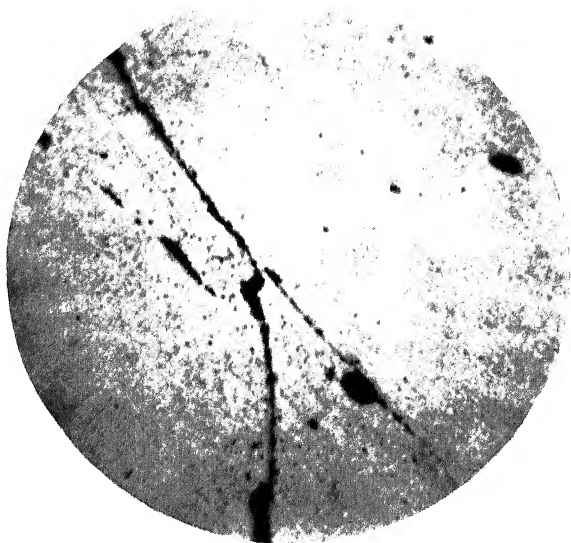
PHOTOGRAPH NO. 41. X50.

Slag in 10-inch rifle, unetched.

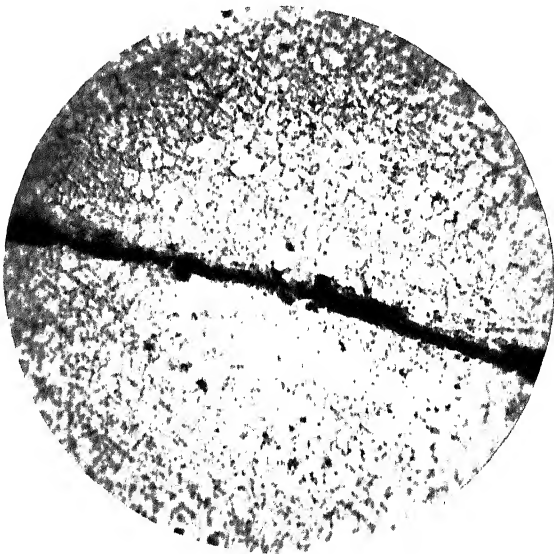
PHOTOGRAPH NO. 43. X50.

Slag and decarbonized area in 10-inch rifle.

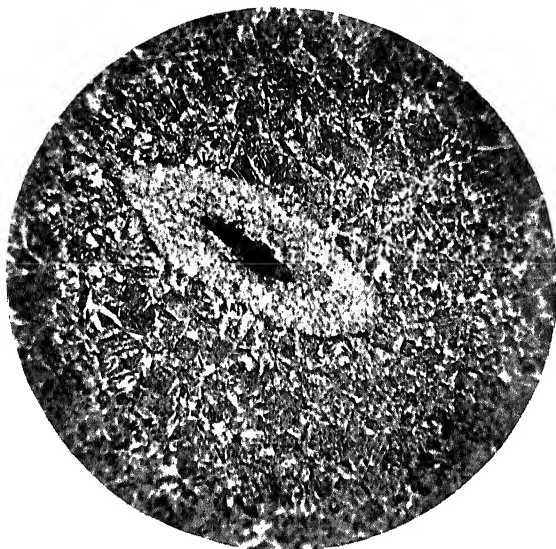
PHOTOGRAPH NO. 44. X50.

Island of slag in decarbonized area in 10-inch rifle.

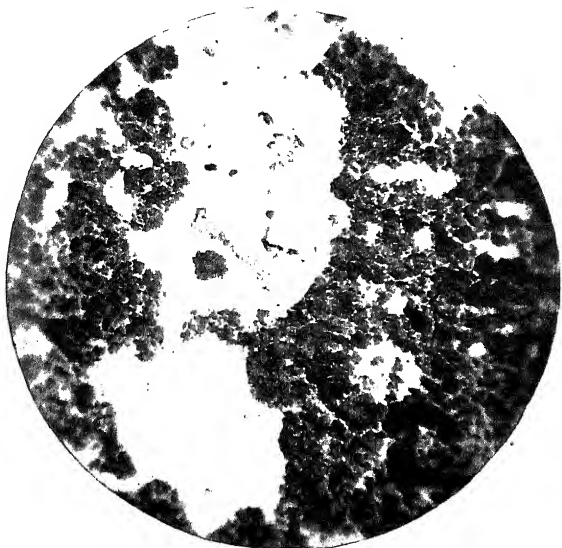
PHOTOGRAPH NO. 46. X50.

Fourteen-inch gun lever. Segregated ferrite (white) with slag inclosures.

This lever was made of cast steel and was broken during the test of the carriage. A microscopic examination revealed the structures shown in photographs Nos. 46 to 51, inclusive.

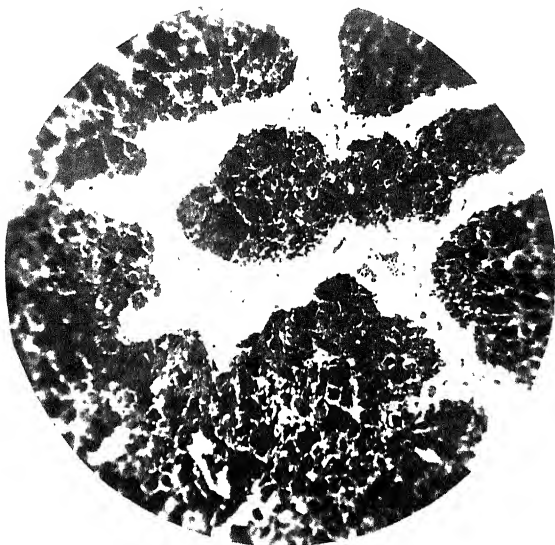
PHOTOGRAPH NO. 48. X50.

Fourteen-inch gun lever. Segregated ferrite (white) with slag inclusions.

In the fractured ends of the test pieces the metal shows decidedly bright spots, and these are due, it is believed, to the presence of the segregated ferrite. Further, it has been noticed that along the stem of the test pieces incipient cracks are developed, as shown in photograph No. 45. It is highly probable that these incipient fractures are developed in such areas as shown in photograph No. 47, which shows a large ferrite field at the edge of the specimen. It is possible that if the forces are transmitted equally throughout the test piece that such a portion would yield more readily where the carbon was lowest. The strength of such a spot would be approximately that of pure iron, or about 40,000 pounds per square inch, while the darker areas which contain more carbon would show considerably higher values. The presence of much slag in the ferrite areas would also increase the brittleness at this point, and would account for the low ductility in some specimens. Further examples of this form of segregation are shown in photographs Nos. 48 and 49.

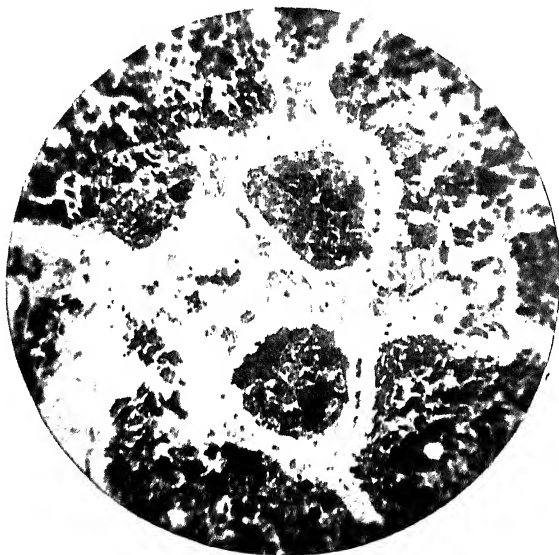
PHOTOGRAPH NO. 49. X50.

Fourteen-inch gun lever. Segregated ferrite with slag inclusions.

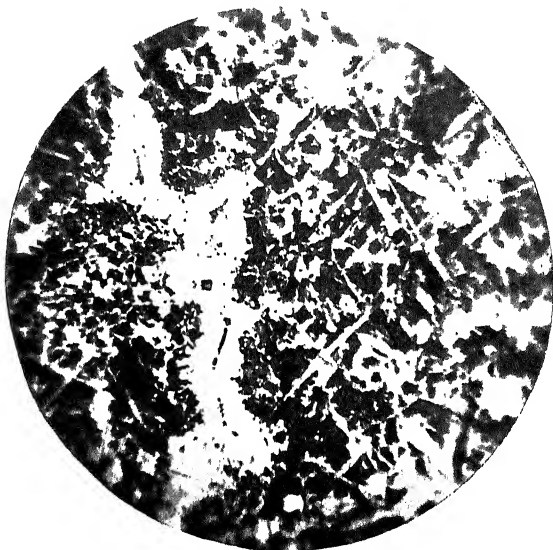
PHOTOGRAPH NO. 50. X50.

Fourteen-inch gun lever. Segregated ferrite and crystalline structure.

The metal has not been annealed in such a way as to remove the original crystallization which took place at the time of solidification. The crystalline structure is shown in photographs Nos. 50 and 51. Proper annealing should have completely wiped out all appearance of this kind. Evidence of this crystalline nature was found in all specimens examined, and it is highly

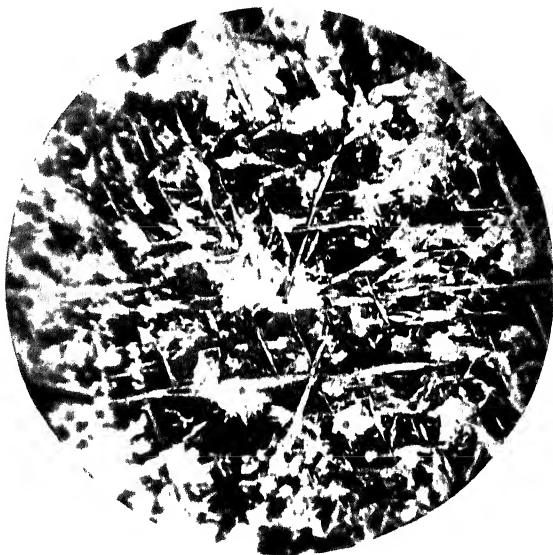
PHOTOGRAPH NO. 51. X50.

Fourteen-inch gun lever. Crystalline structure.

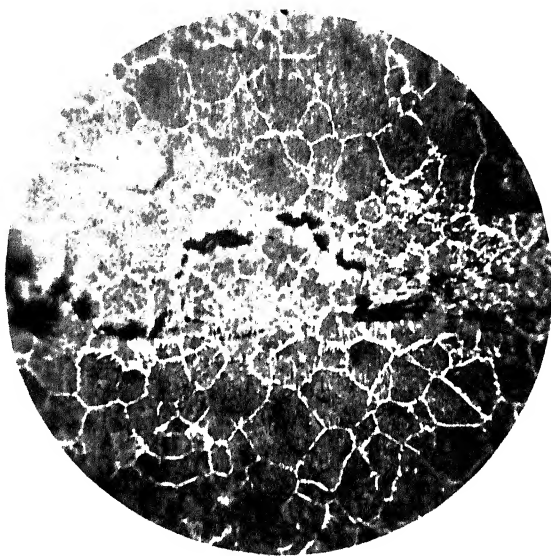
PHOTOGRAPH NO. 53. X50.

Twelve-inch gun. Microstructure showing slag and fissures.

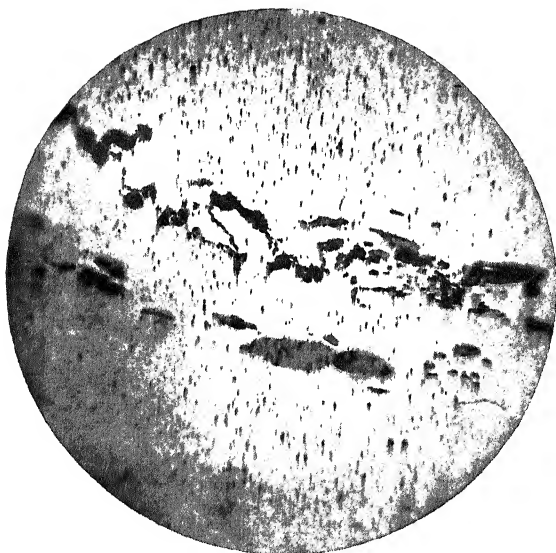
PHOTOGRAPH NO. 54. X50.

Twelve-inch gun. Slag in unetched specimen.

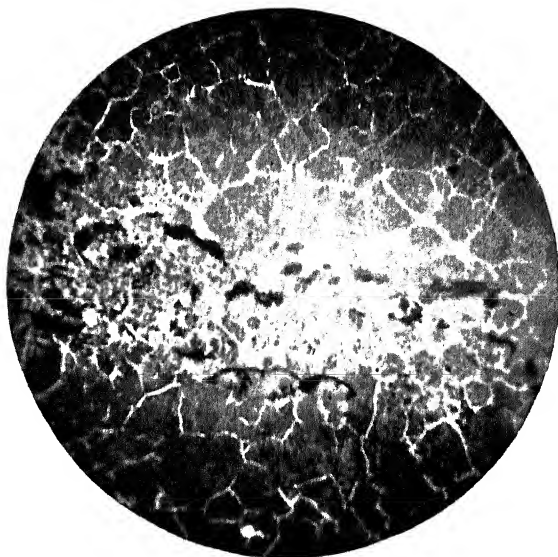
PHOTOGRAPH NO. 55. X50.

Twelve-inch gun. Same area as No. 54, etched with alcoholic nitric acid.
